April 26-29 Status

Eric J. Mannel

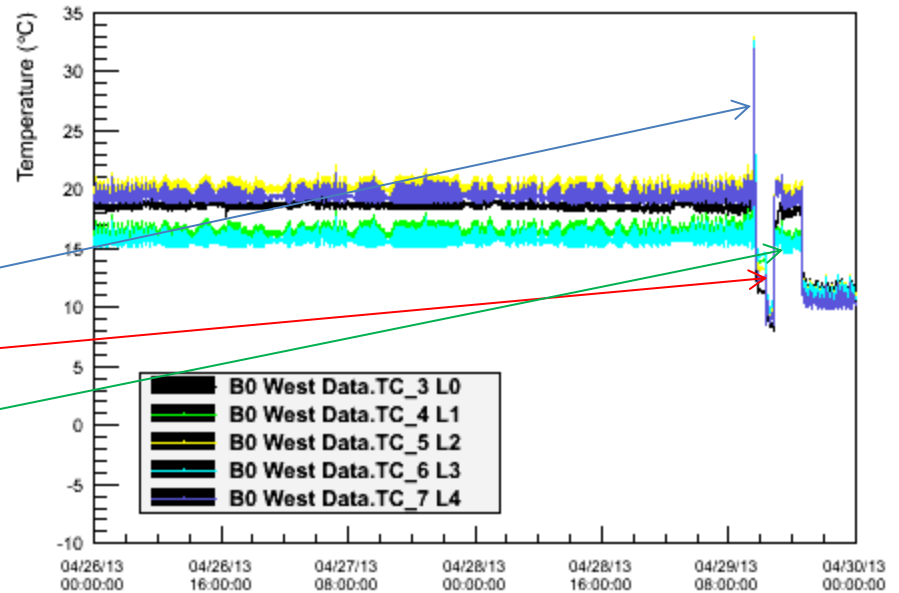
VTX Thermocouples

- B0 L0-L4 (West Ladders)
- Time period 28-Apr through 29-Apr.
- Start of access and testing
- Shutdown to inspect leak
- Post repair testing
- Similar features for B1 ladders (next slide)

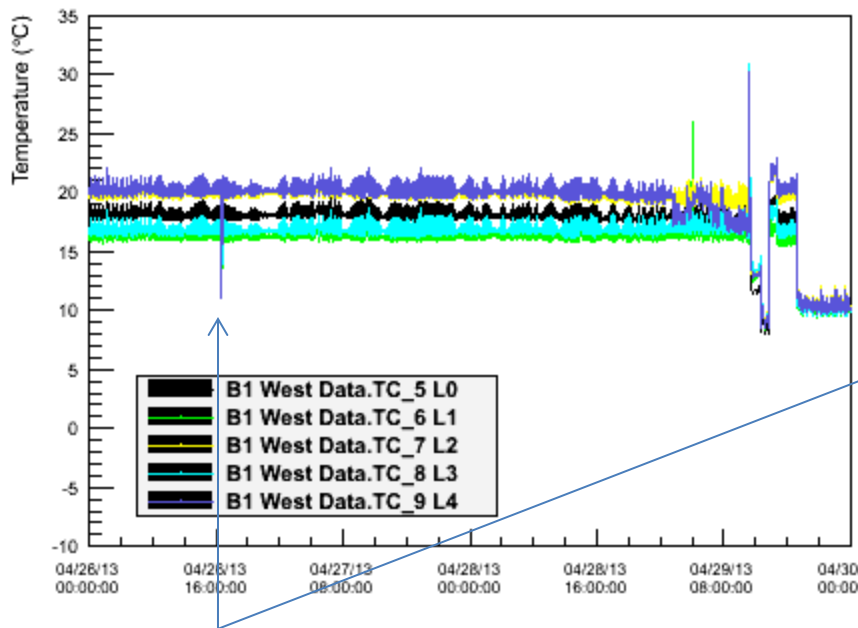
VTX Thermocouples B1 L0-L9

Thermocouple trip,
RUN e-log ID 4204, tripped TC
not reported in log.

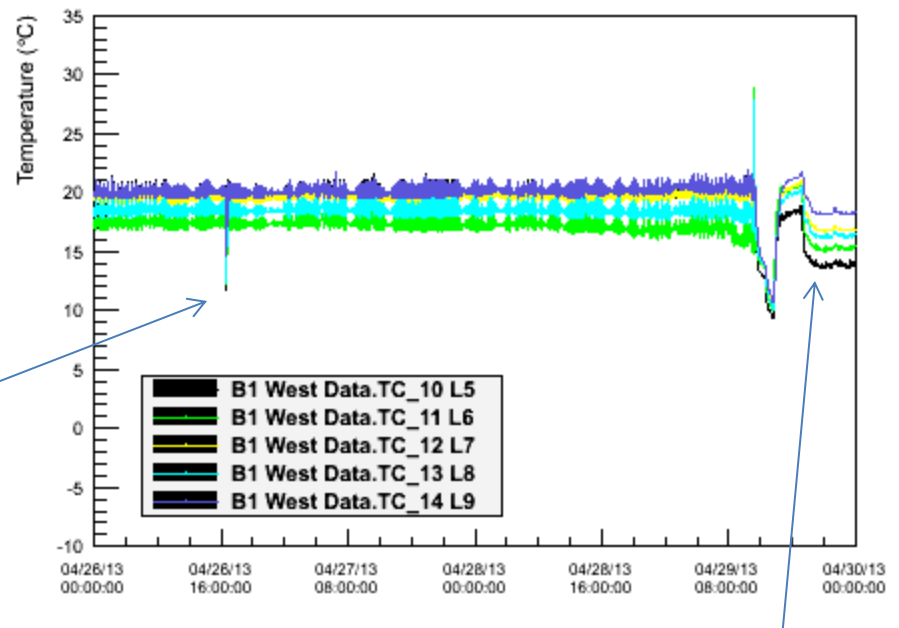
Coolant flow to the ladders has been stopped

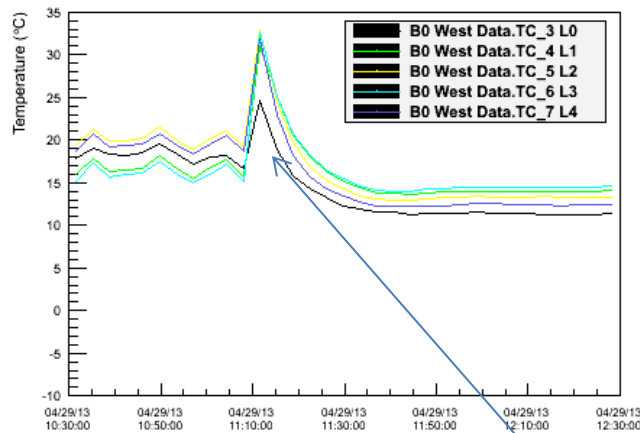
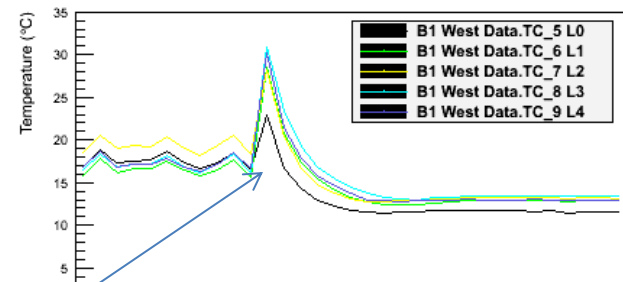
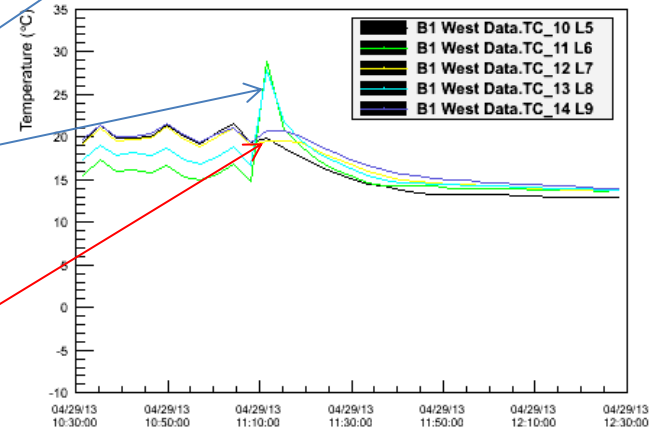
VTX Temperatures at Start of Access

Coolant flow being interrupted?

Maximum temperature 30C, trip temperature

Note: Only 3 ladders don't increase, L5, L7 and L8

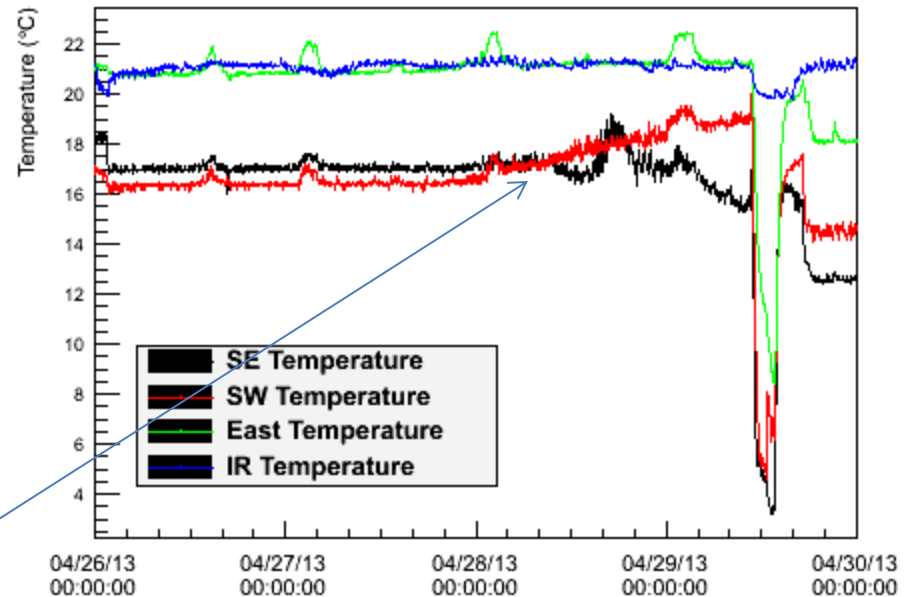
Aux Thermocouples

- IR temperature
- 2 thermocouples in the enclosure, 1 in center of East barrel, 2 on south end outside of FVTX cage on the bottom. See next slide.
- Note gradual increase in SW temperature over 36 hours.
- This is also can be seen in FVTX SW Station 0 temperatures

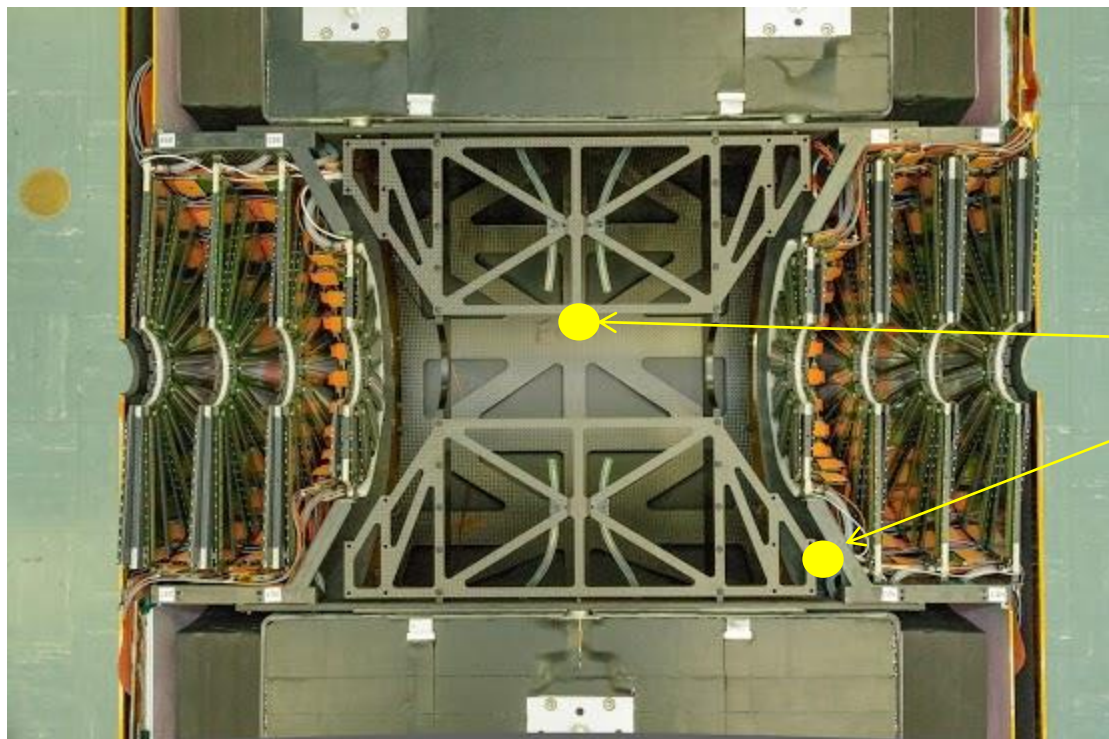
Location of Aux. Thermocouples

Approximate location of auxiliary thermocouples.
East thermocouple
Southeast thermocouple
Southwest (not shown) is in similar location on west side.
All TC's were installed "floating" so they would not touch any surfaces.

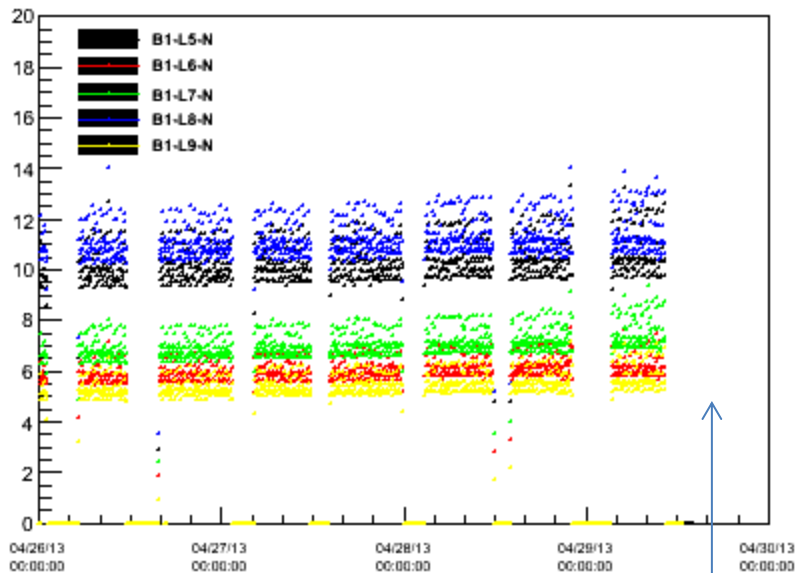
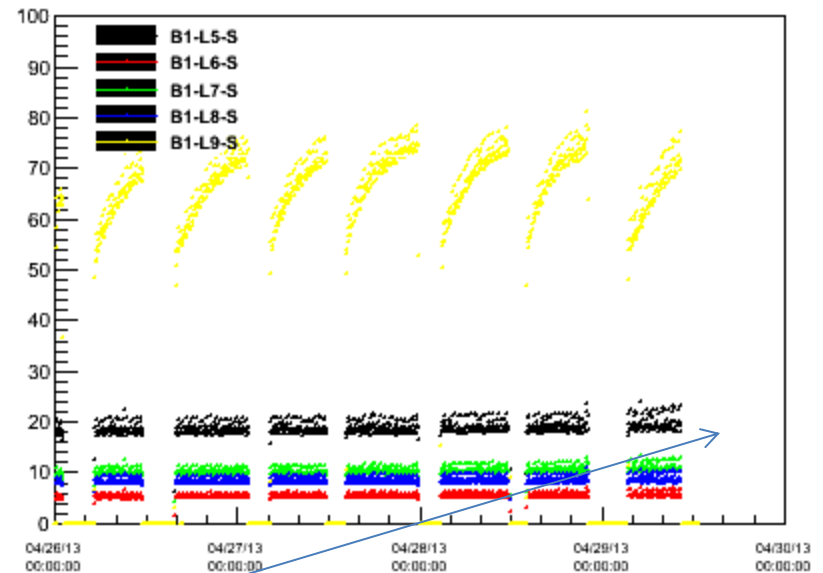
B1 L5-L9 April 26-30

Ladder bias disabled after access
