VTX Status Report

Eric J. Mannel

DC Meeting

November 7, 2012

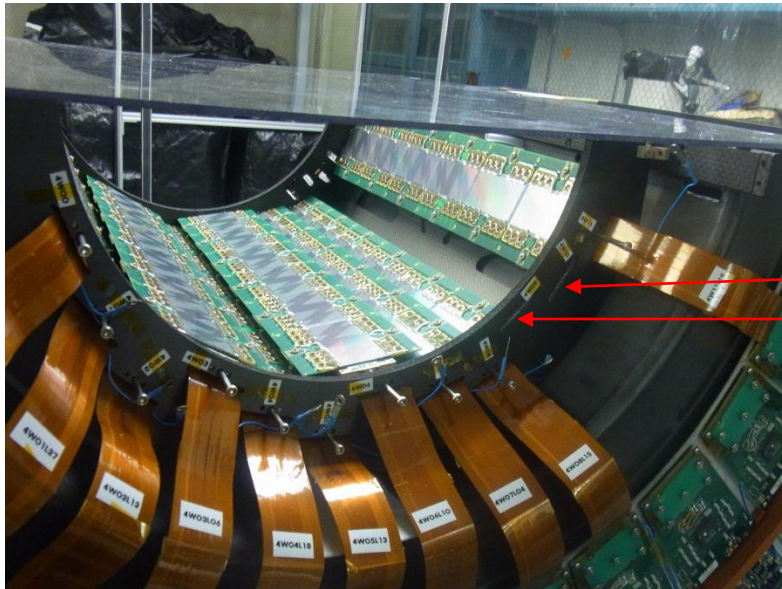
During maintenance: VTX-Stripixel west side

- B3L09 has to be removed in order to fix bad ladder B3L10.

B3L10

B3L09

- The good news: B3L09 has also two bad RCCs. We took the opportunity to replace the two bad RCCs, now B3L09 is working 100%.

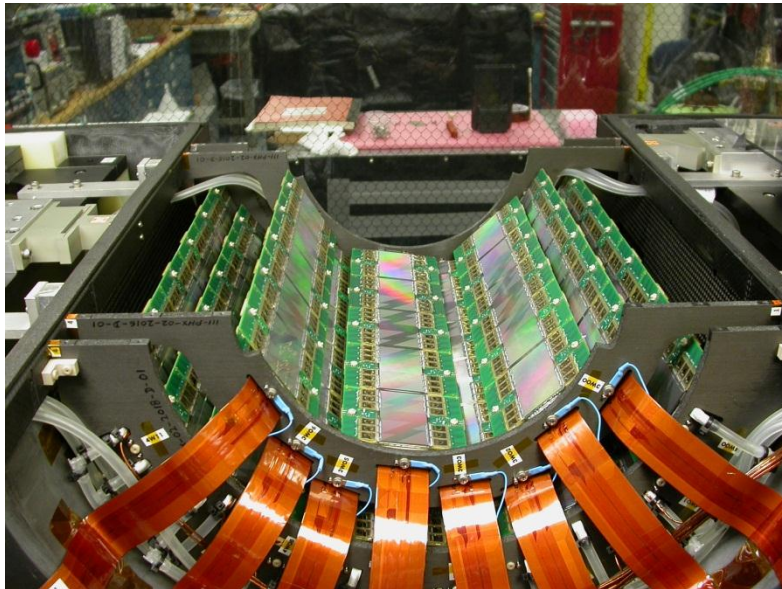
Maintenance: Done

- One LDTBs board was replaced. B3L09, the new B3L10 and new B2L04 fixed and mounted back to the west barrels. We do testing in every stage to ensure success. See details in the next slides.

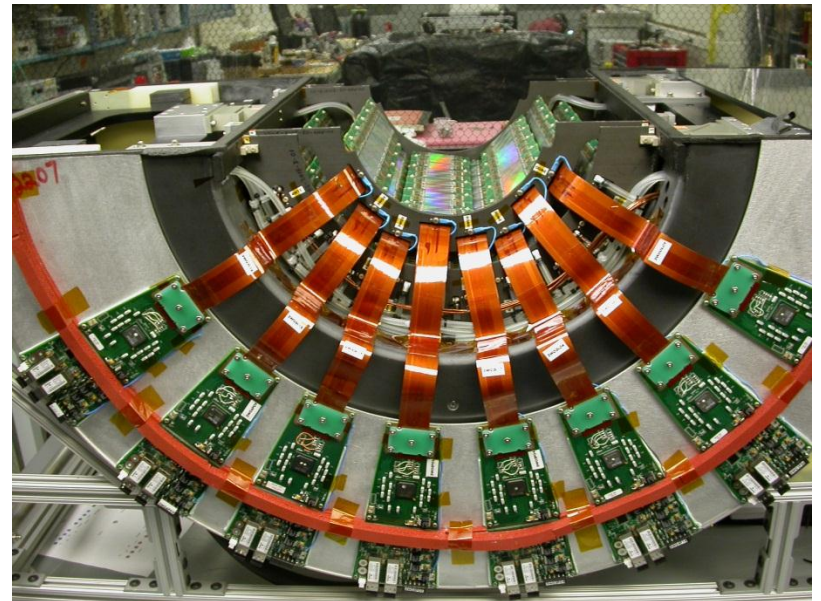
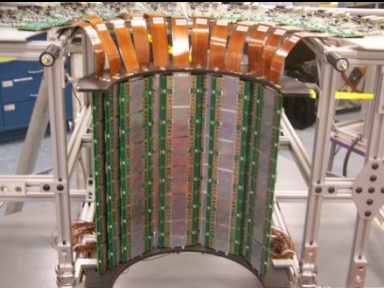
**Half Barrels 3 and 4 into each other with LDTBs
West VTX-Stripixel**

- 1) **B2L02:** LDTB board problem (analog prb.). Its LDTB board was replaced (wrk. 100%)
- 2) **B3L10:** was removed, tested and the cause of the problem was identified
→ B3L10 was replaced by a spare ladder and put back to barrel #4 (wrk. 84%)
- 3) **B3L09:** was removed, tested, two RCCs replaced and put back to the barrel #4 (wrk. 100%)
- 4) **B2L04 (barrel 3):** removed: it has serious issues in ADC data (configuration and channel data are excellent): → replaced by new spare ladder (work. 100%)
