VTX leak issue

Hubert van Hecke

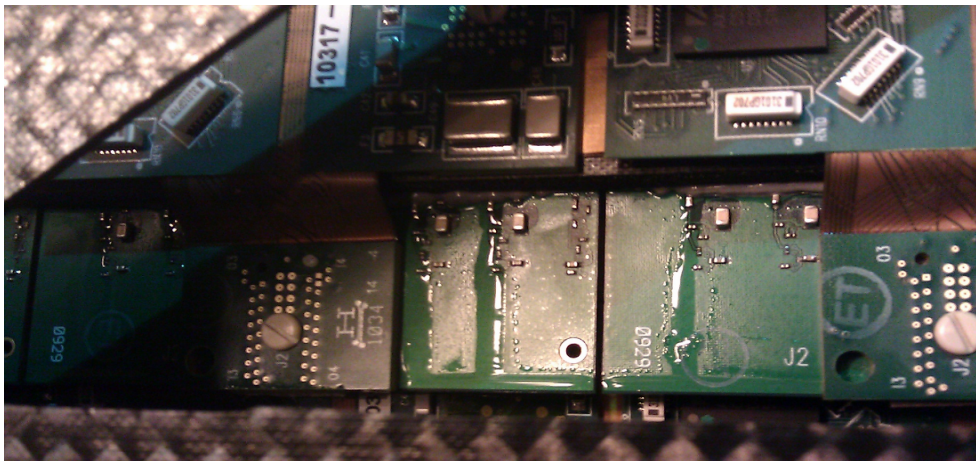
- At the start of operations (Dec 17), massive leaks were observed (~2 gals/day), only in layer 4 (outermost) of the stripixels

Pressure tests were done to establish that the leaks were not coming from the pixels, or from the VTX pixel barrels 1 or 2, or from the FVTX.

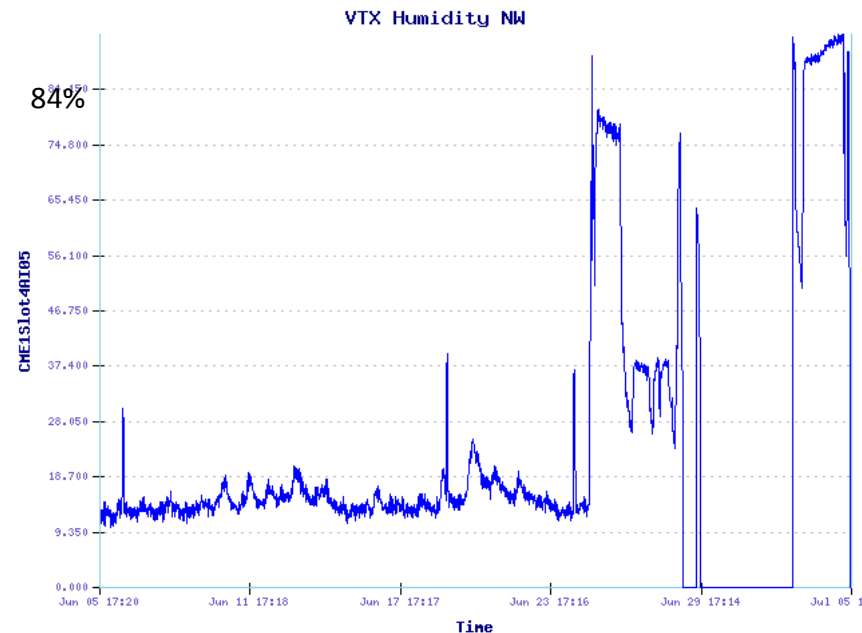
Our logs show that at the end of run 12, after electronics tests were done, the cooling was left running, with the detector in a state that did not provide a good seal to outside air. For a few days, the humidity inside the detector reached 100%

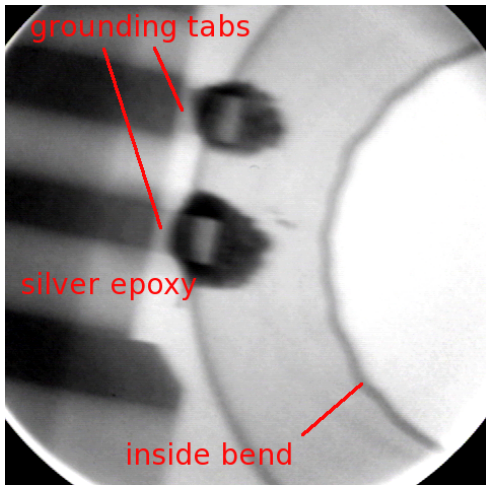
- X-ray of a tube. This was to establish whether or now we would be able to see a small hole
- A spare tube was prepared with a small hole punctured in it

A small hole would be undetectable with this technique

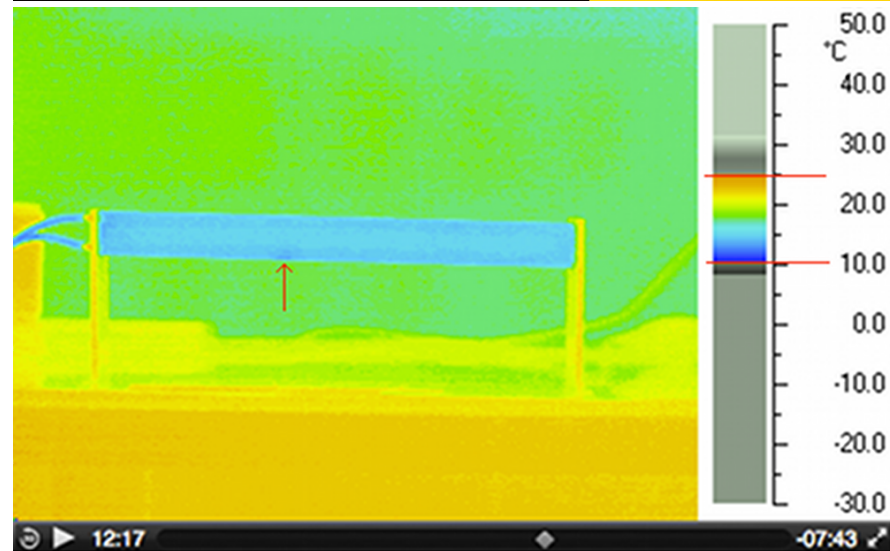
We cycled the coolant, and observed a cold spot during the warm-up phase, as leaked coolant evaporated. This allowed us to pinpoint the leak location

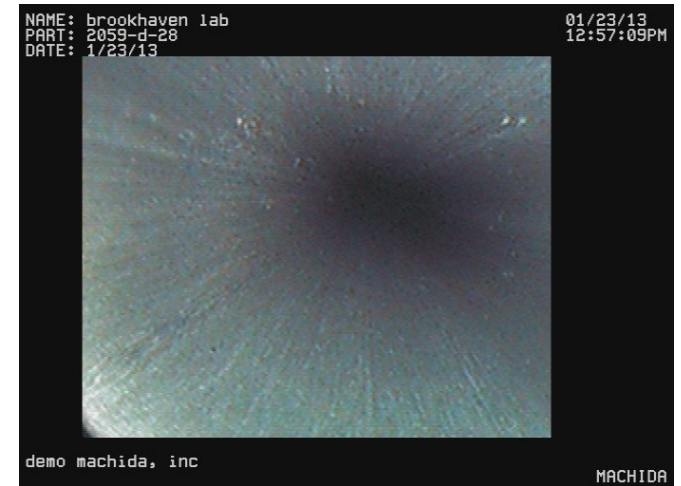
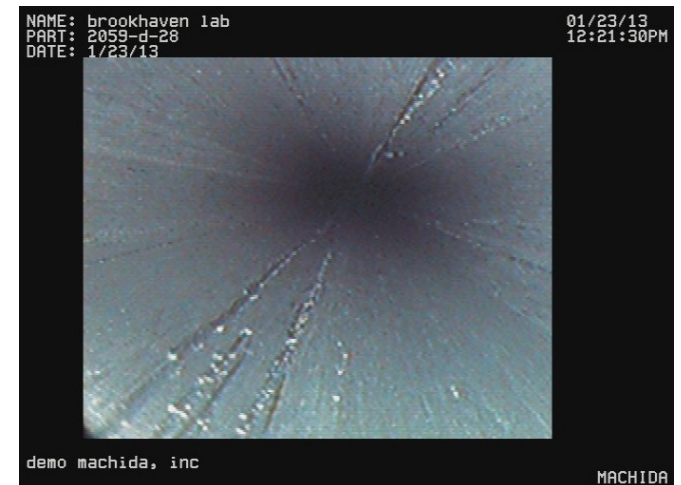
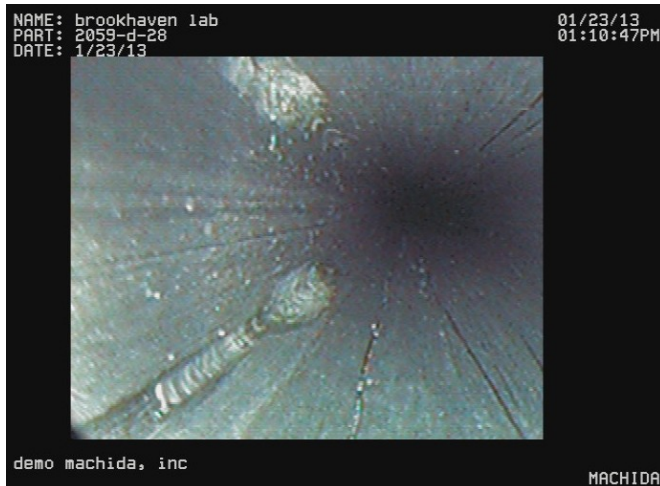
- Machida has a flexible borescope with a 2mm-high camera, 1024x640 px. This is just small enough to slide into the tube.
- An unvisited section is pristine
- The camera itself scratches the soft Aluminum
- In a few places, we saw unusual features.

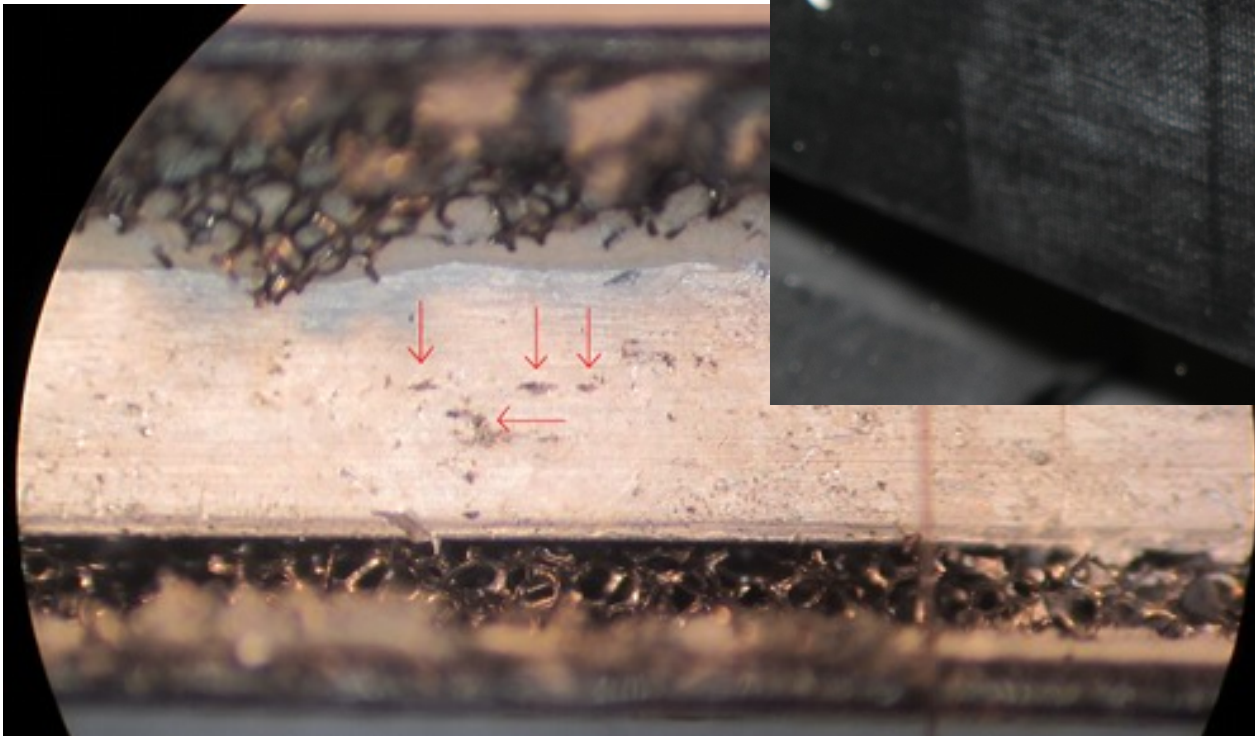
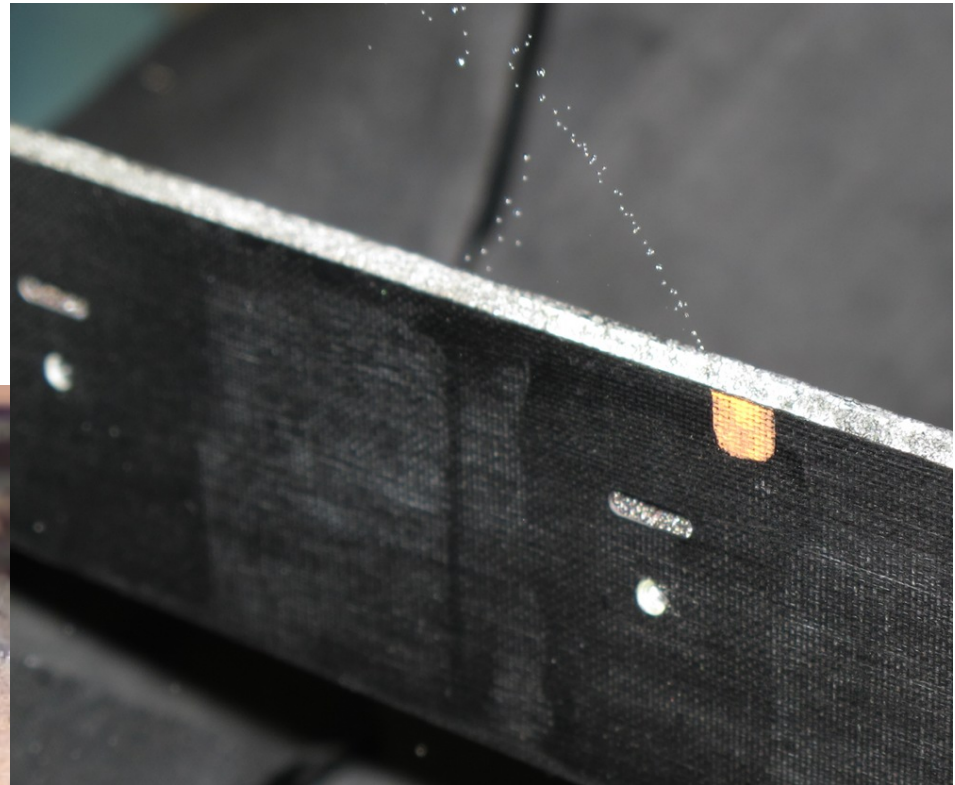
With the leak location identified, we removed the outside carbon foam, and saw the leak. Small craters could be seen

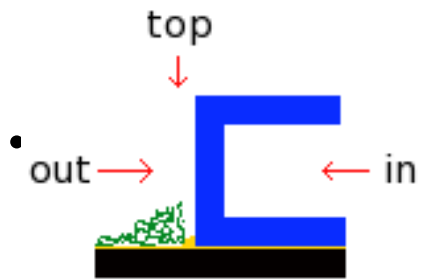
Inside/outside/top views

The inside of the tube is very clean, the outside shows signs of corrosion

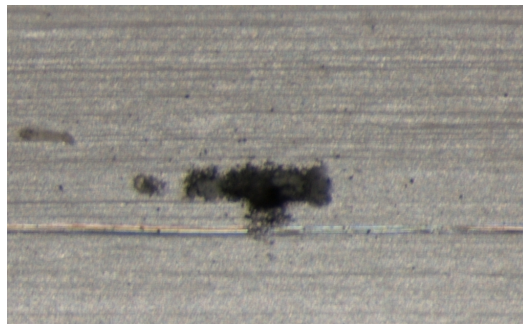
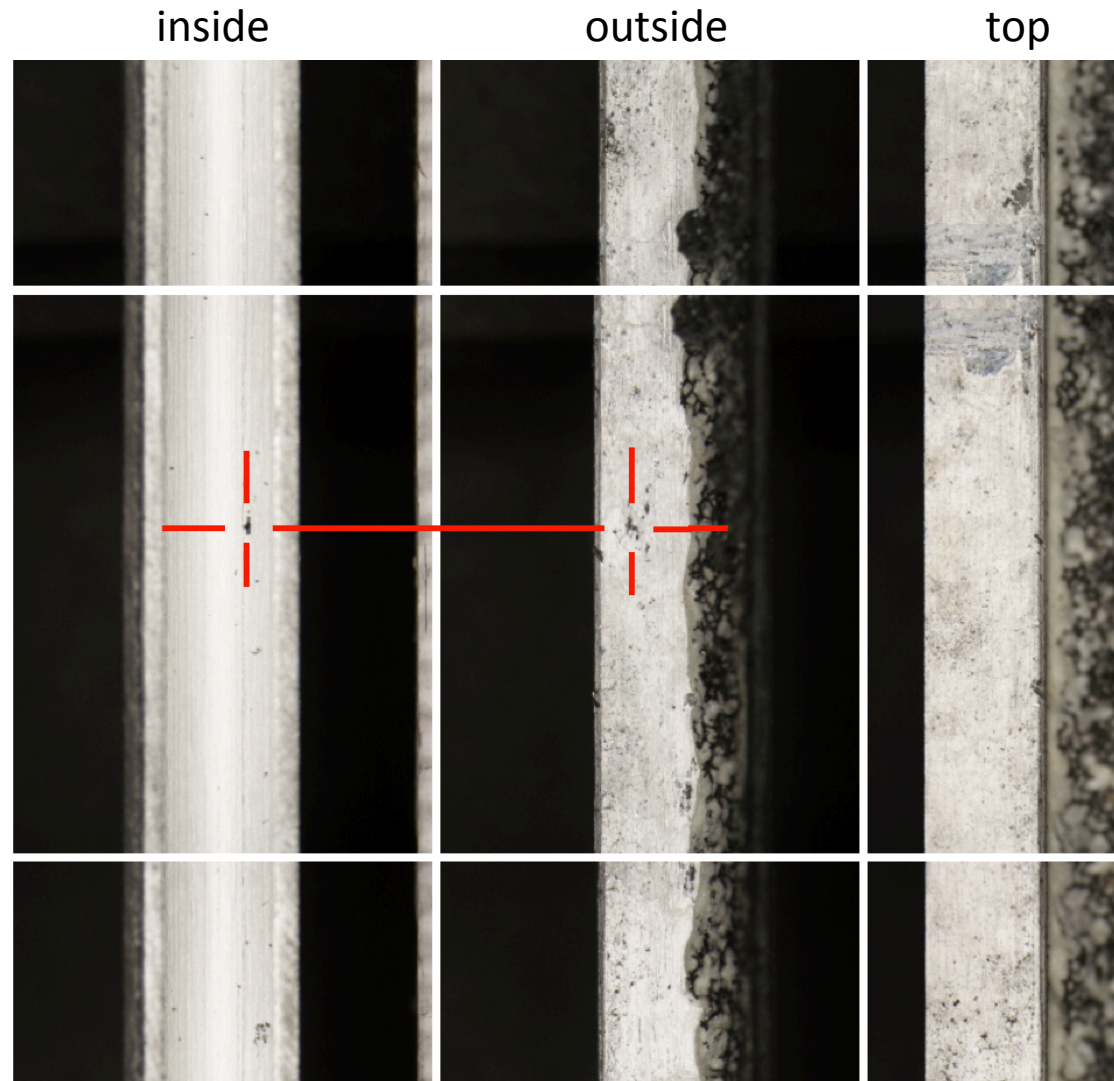
The leak can be found on the inside of the tube

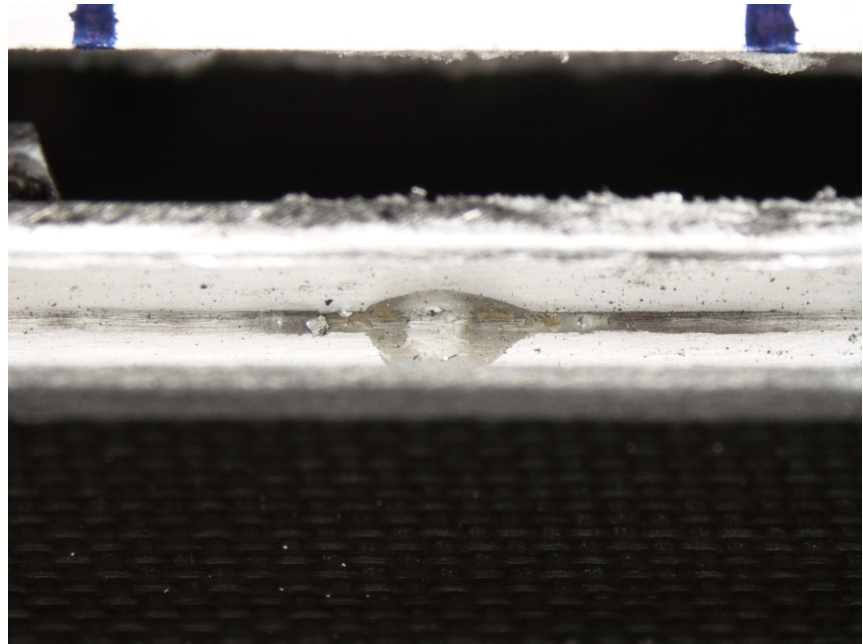
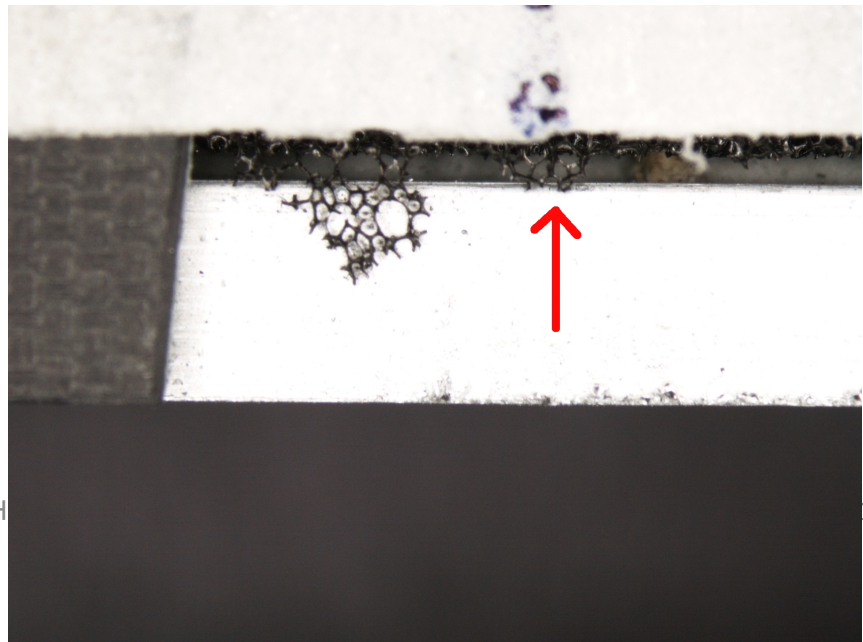
Inside/outside features

- Feature seen on the inside corresponds to a location where carbon foam remained attached to the outside

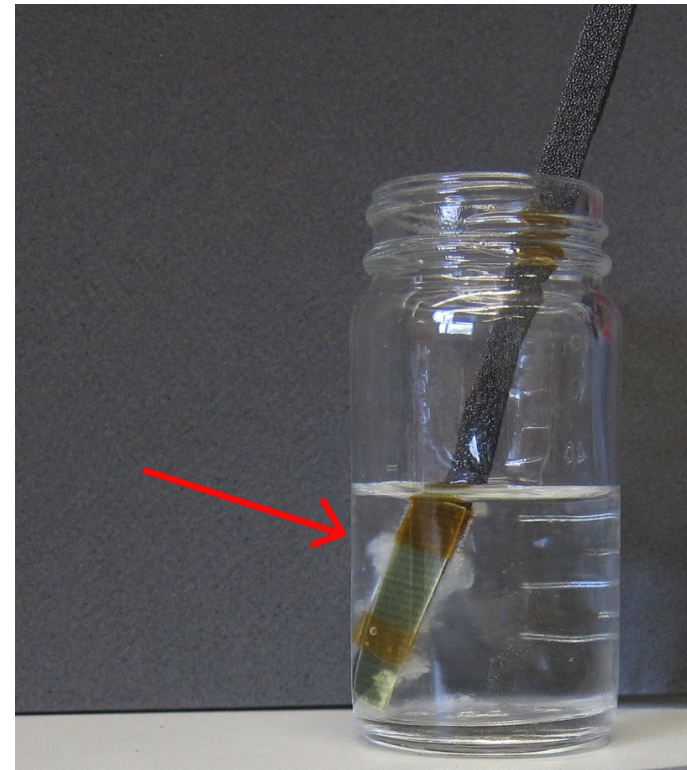
Within a few days, a whitish, very low density material formed at the interface between the Al and C.

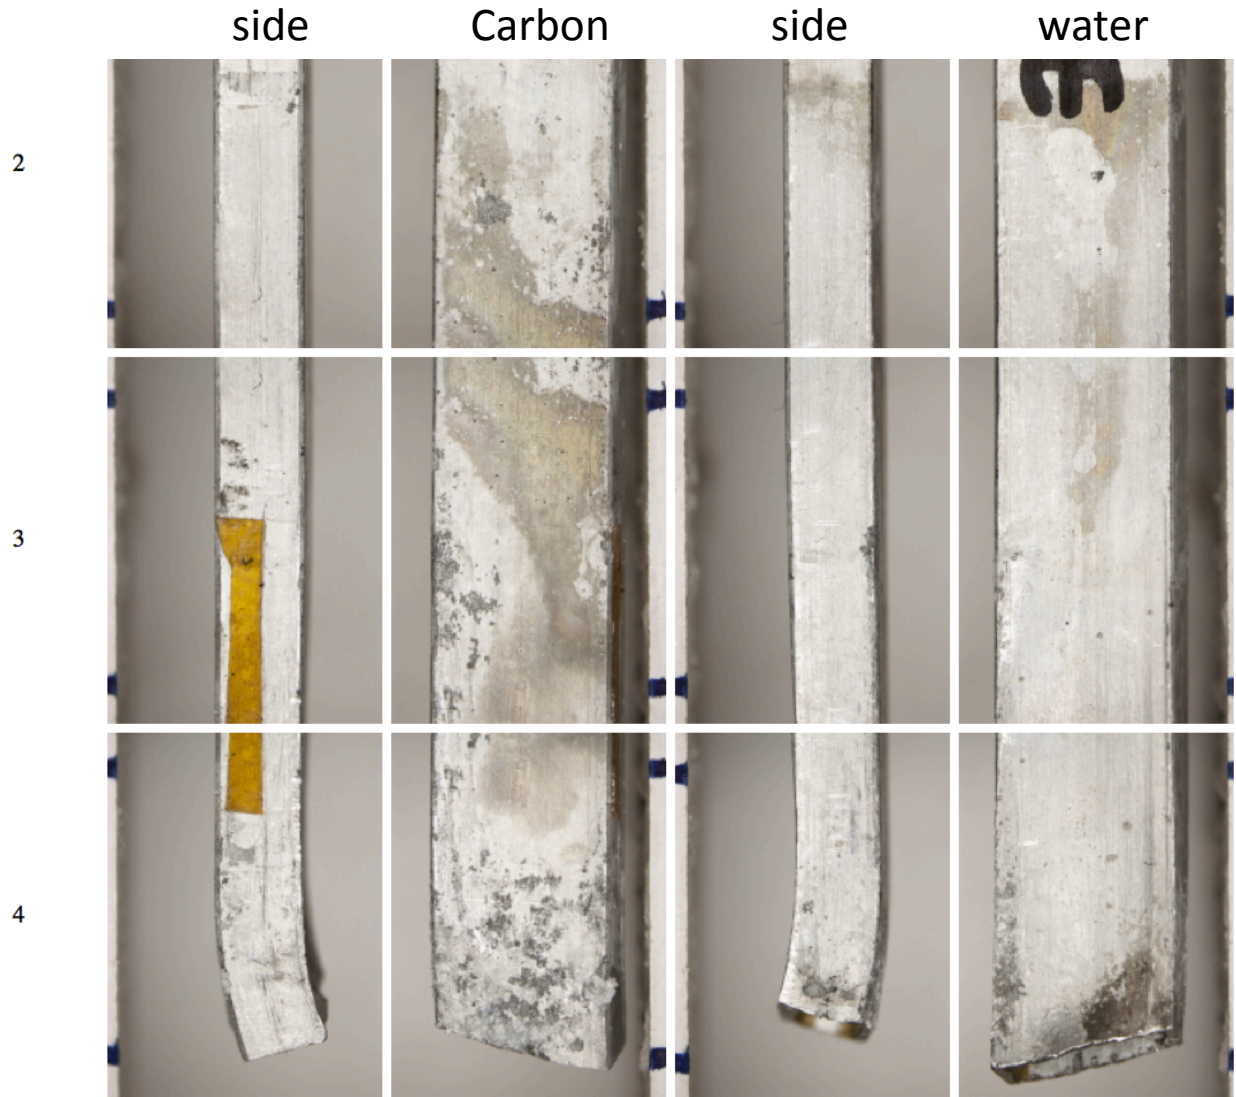
After 9 days I removed the samples from the water. The side facing the carbon shows the same discoloration and pitting as seen on the detector staves.

The side facing the water remained relatively clean

- The leaks were caused by galvanic corrosion between the Aluminum and the carbon foam
- No evidence that Novec played a role in the corrosion
- Water was introduced to the interface by condensation. Some of this may have already occurred in the first two years, but the events at the end of run-12 caused the sudden massive leaks seen in December
- The VTX pixel staves and the FVTX cooling channels are not affected by this effect, and these systems can be safely operated.
