VTX leak issue

Hubert van Hecke

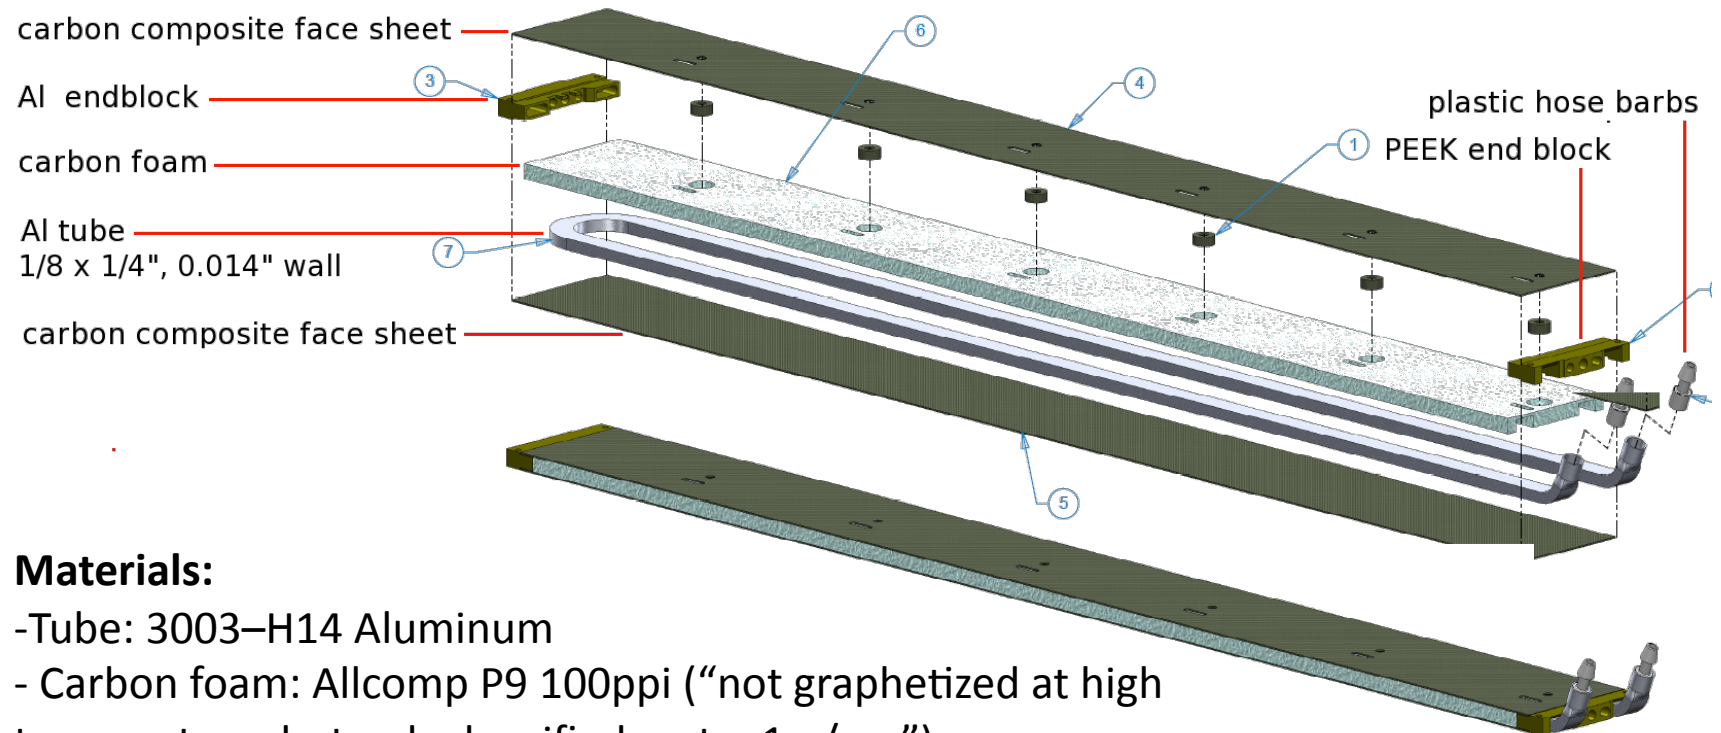
Cooling stave

There are xx staves that make up stripixel barrel 4. Silicon stripixel assemblies are mounted onto these cooling staves (not shown).

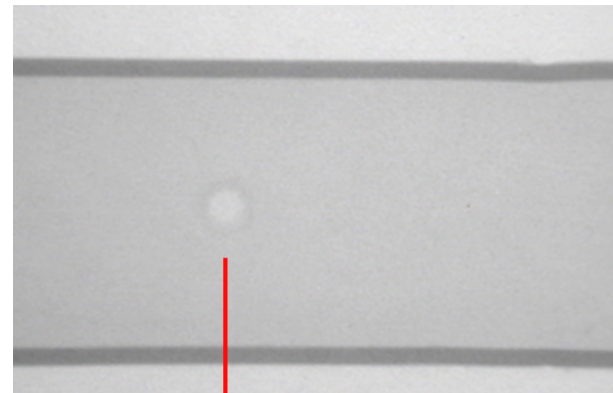
Top view

A small hole would be undetectable with this technique

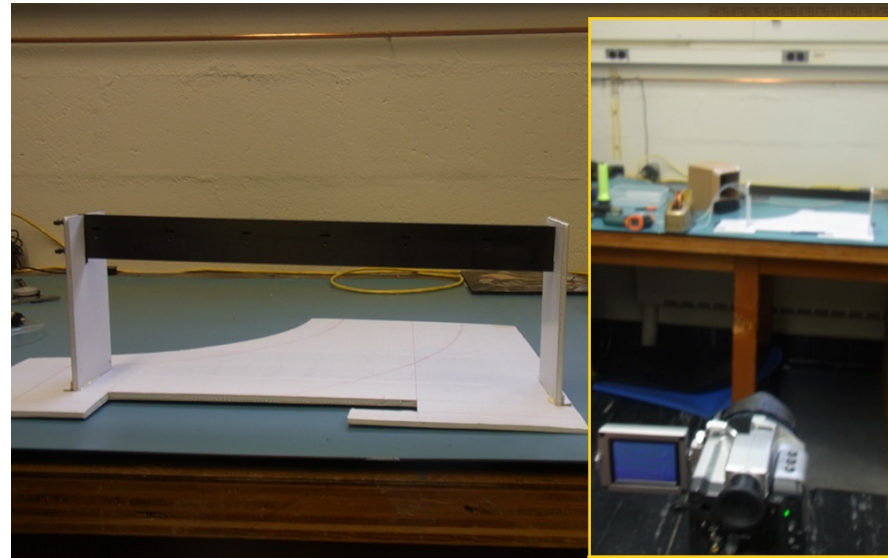
2: Thermal imaging

We set up one of the known leaking staves, and hooked it up to a cooling system

We cycled the coolant, and observed a cold spot during the warm-up phase, as leaked coolant evaporated. This allowed us to pinpoint the leak location

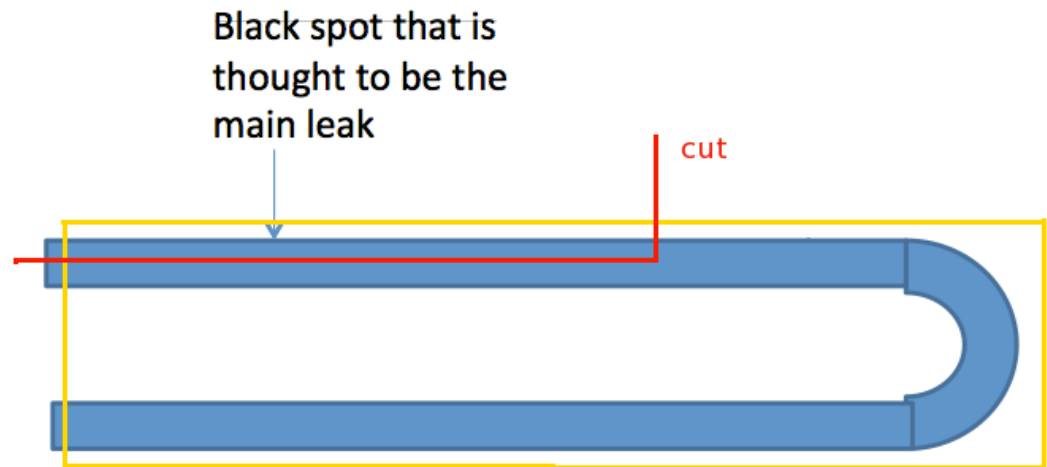
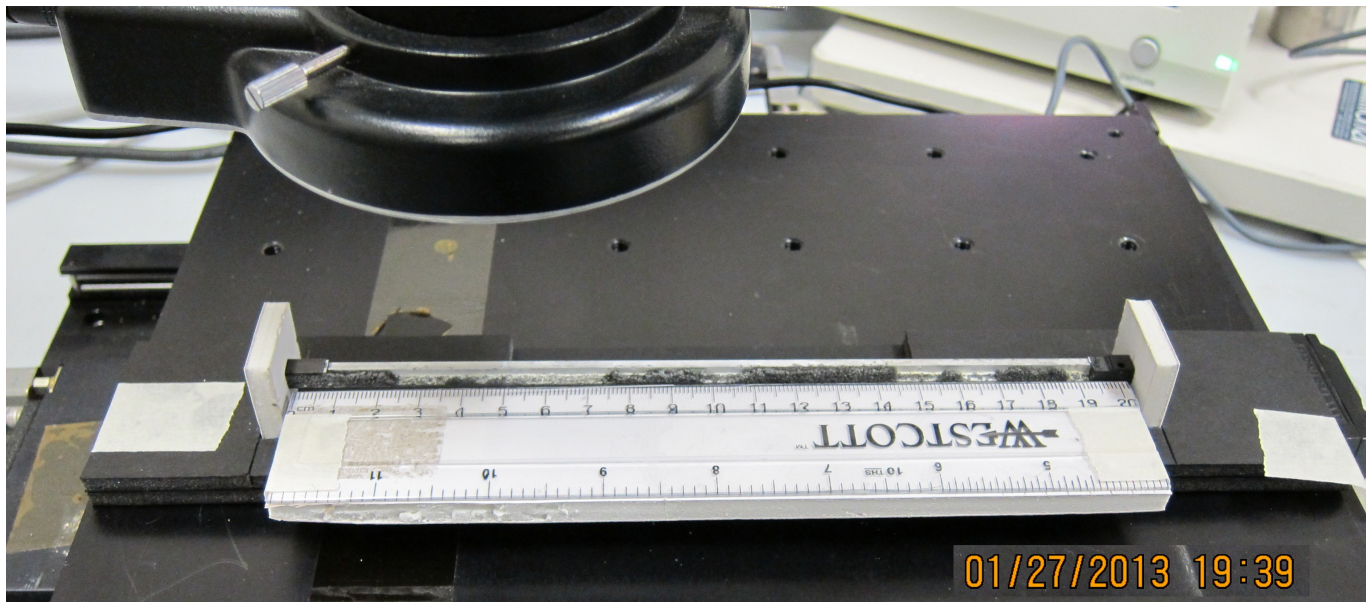
Cutting the tube open

A jig allows a scan of the cut section in 1 cm steps, and registration of front/back/top images

The inside of the tube is very clean, the outside shows signs of corrosion

The leak can be found on the inside of the tube

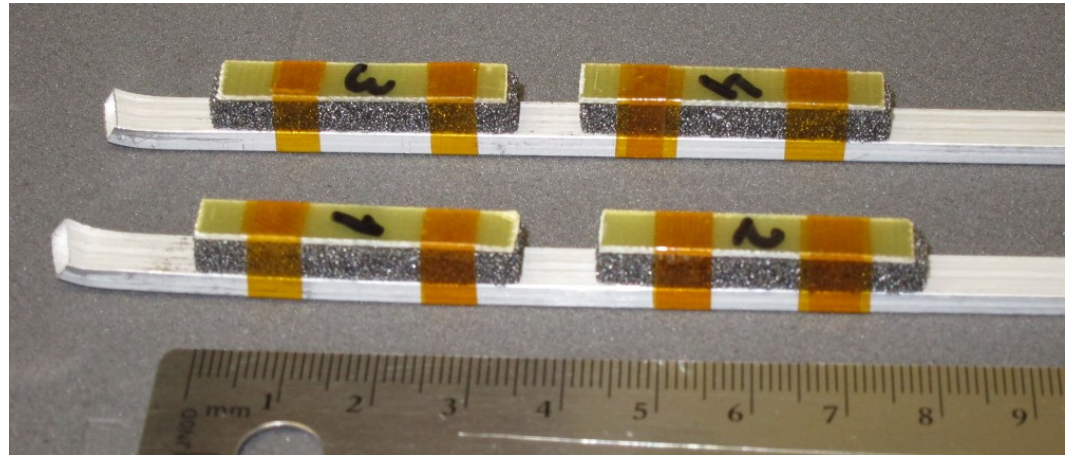
Active corrosion tests - 1

Four carbon foam/Aluminum sandwiches, immersed in tap water

Within a few days, a whitish, very low density material formed at the interface between the Al and C.

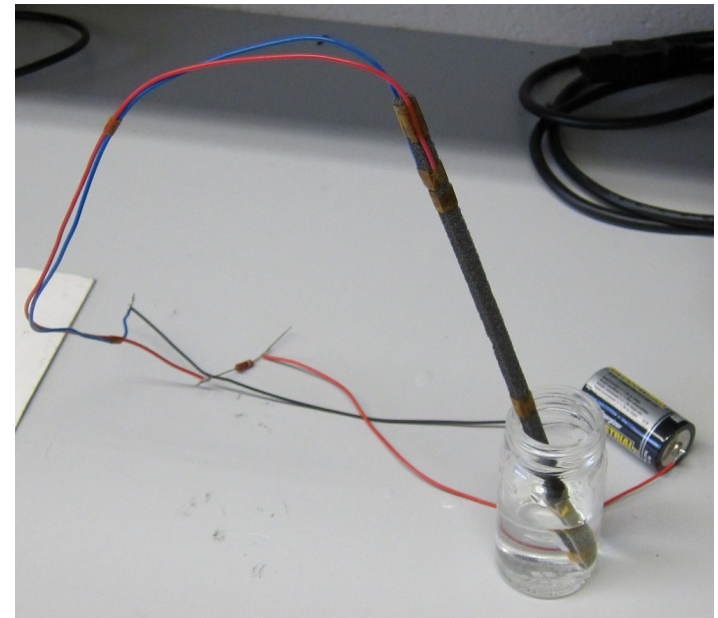
Aluminum/carbon foam sandwich, immersed in tap water, and assisted by ~30 mA of current
